POTENTIAL CAUSES OF HISTORICAL LANDSLIDE AND A PROBABILISTIC APPROACH TO ASSESSING FUTURE RISK FOR DEVELOPMENT OF JEROME REST AREA

S. D. NEELY, P.E. (TERRACON)¹

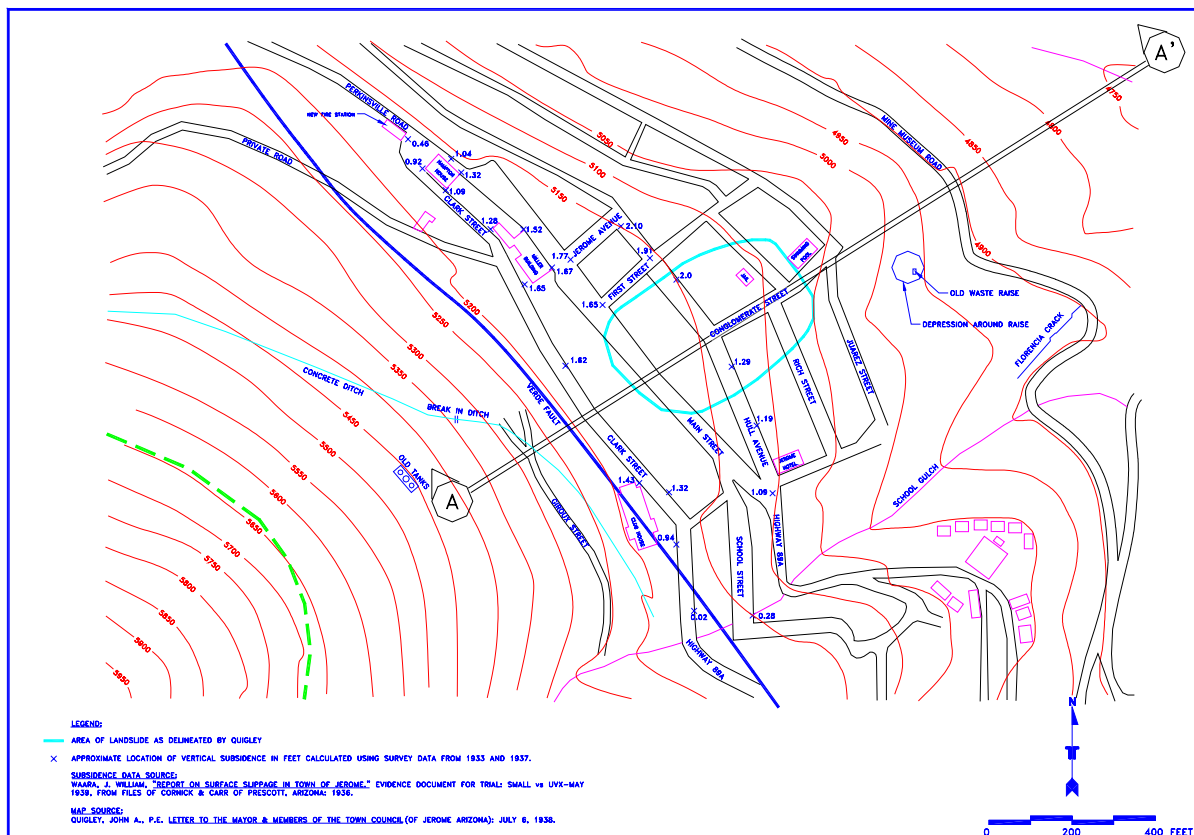
FIGURE 1: Quigley Map of Jerome in 1936 depicting the extent of the landslide.

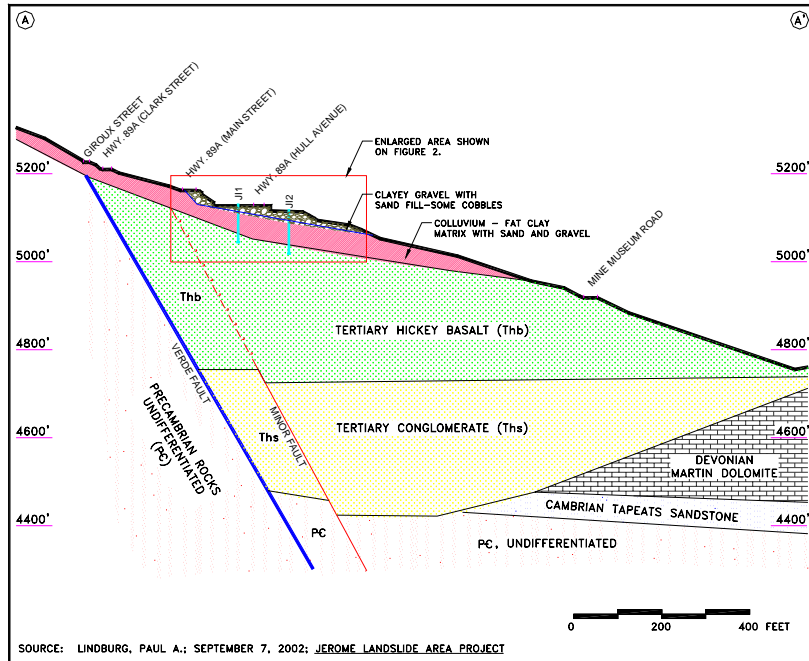
FIGURE 2: Cross section through landslide depicting geology and surface geometry.

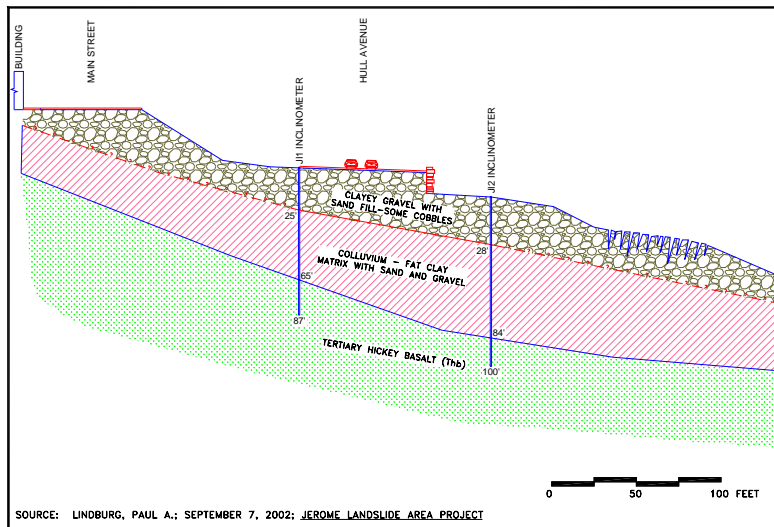
hole results show that flexures in the Verde fault zone can vary from a few inches to 30 or more feet wide.” Figure 3 shows the present day geologic cross section through the town of Jerome.

FIGURE 3: Close up of cross section shown in Figure 2.

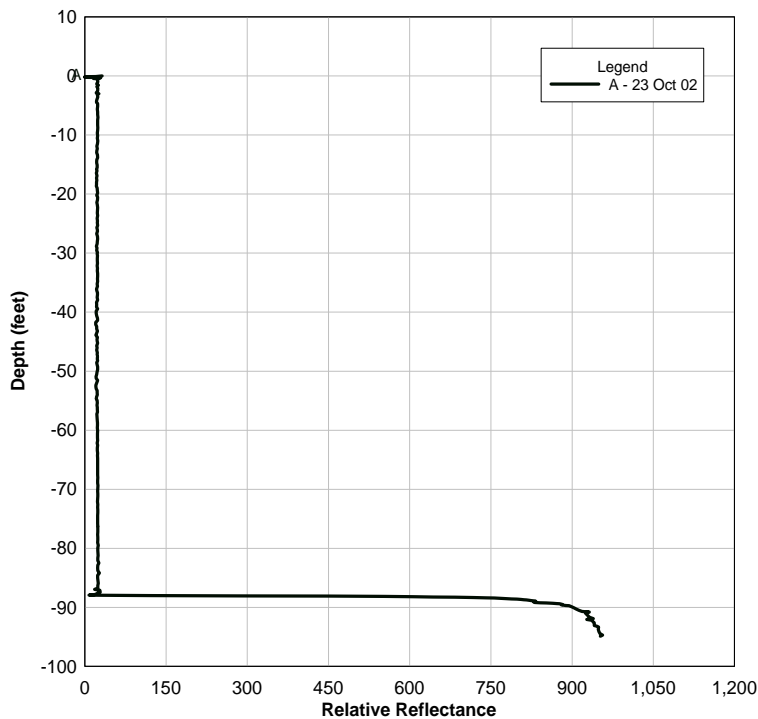
FIGURE 4: TDR plot for J1a.

Time Domain Reflectometry Results: Field measurement data was obtained from TDR cables installed at Boring Nos. JI1a and JI2a on October 23, 2002 by Kane Geo Tech, Inc. The results of the TDR data indicated the slope had not moved between installation of the TDR cables and October 23, 2002. A typical graph of the TDR data is presented below.

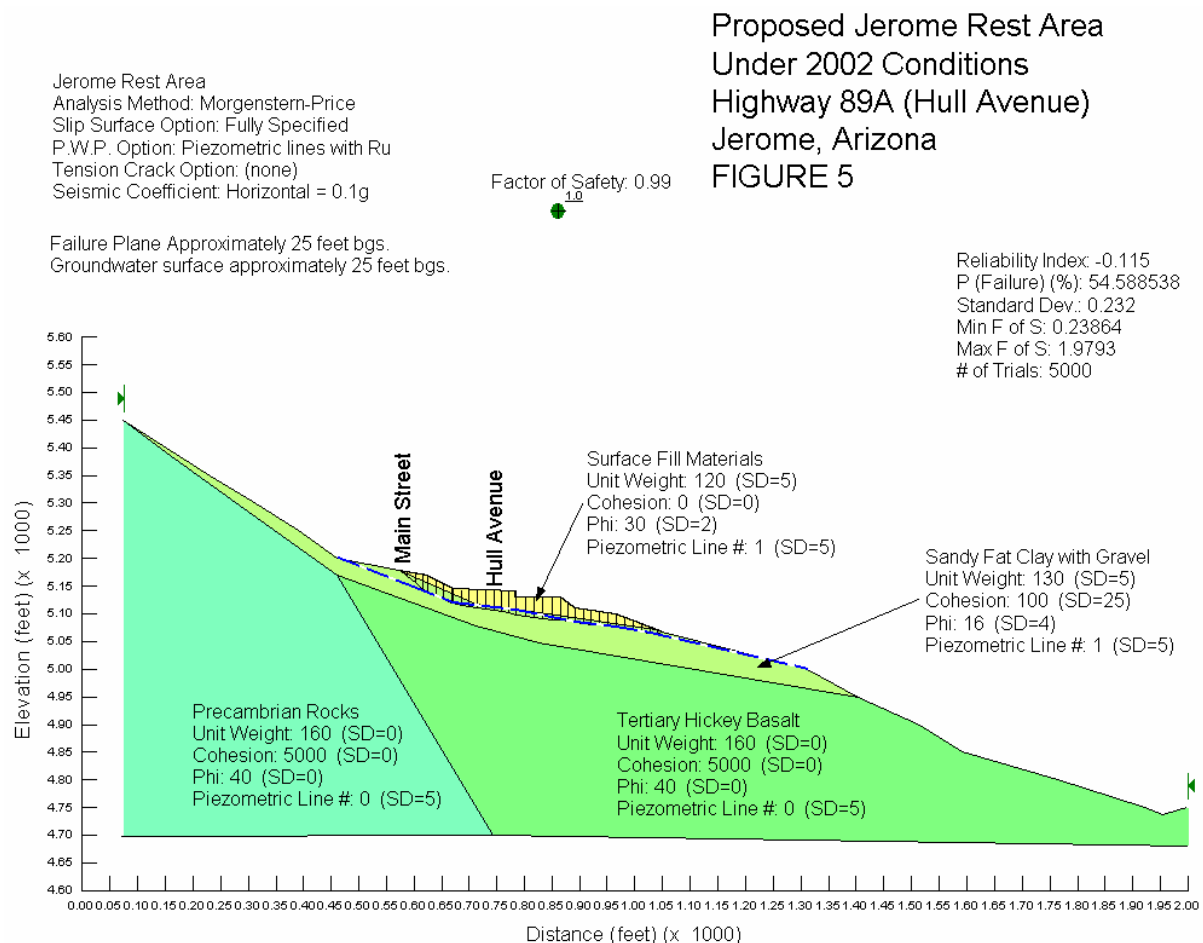
For purposes of our stability evaluations, a cross-section (A - A') through the landslide area and the portions of the slope above and below the site of the rest area was developed. A specific failure plane was analyzed based on data obtained from the historical review and our field explorations. The failure plane slopes steeply to the east near the middle of Main Street, becomes planar for approximately 400 feet and slopes slightly up to the ground surface where it day-lights at the surface. The failure plane is parallel with the ground surface and located at a depth of 25 to 35 feet. The location of the cross section is shown on Quigley's map (Figure 1) with a few alterations to the ground surface to represent present day topography across the landslide area.

FIGURE 5: Slope Stability cross section; typical.

Based upon our analyses, the slope is stable under 2002 conditions provided there are no strong ground motion forces added to the slope and based on current groundwater conditions. In addition, the results of the stability analyses indicate the safety factor is sensitive to the magnitude of the seismic coefficient.

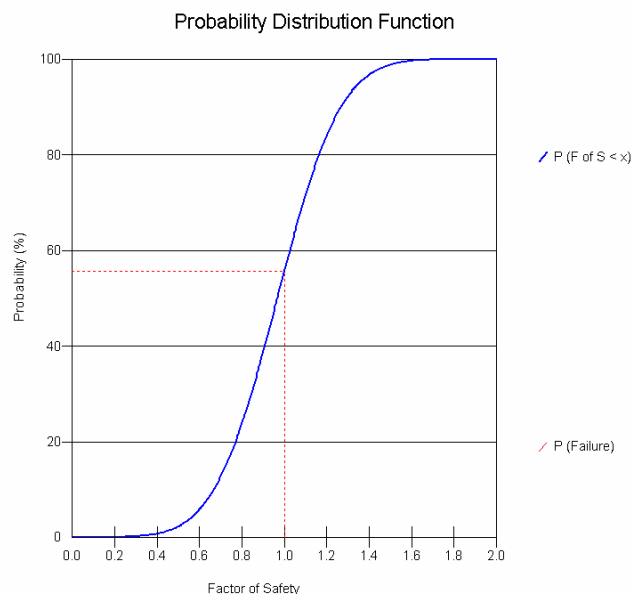
FIGURE 6: Probability Distribution graph for seismic coefficient of 0.1g.

Conclusions: The results show there is generally a one in seven (15%) chance of slope instability under 2002 conditions when the seismic coefficient is 0.02g. When the seismic coefficient is 0.10g the probability is generally one in two (55%).

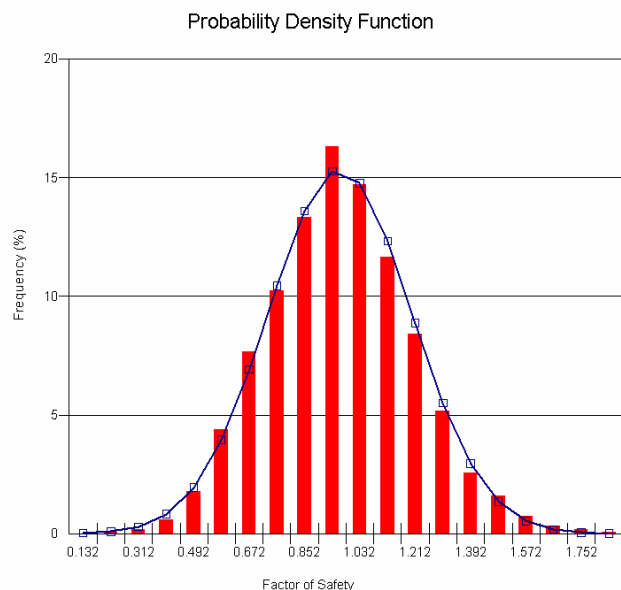
FIGURE 7: Probability Density graph for seismic coefficient of 0.1g.
